# Manhole Inspection Summary

Manhole # S51C\_\_007MH

Insp Date: **5/1/08 2:11 PM**

**Location** Address: **165 n decker st**

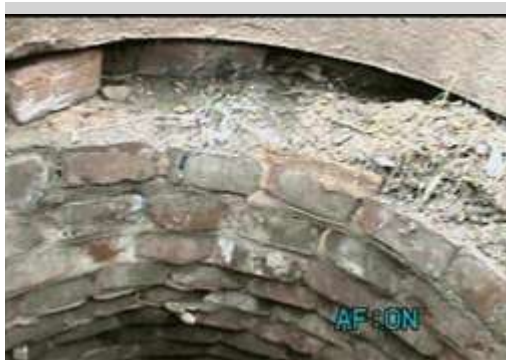
Defect 2

**Frame** Offset: **4** (in.) Condition: ☒ Sound ☐ Cracked ☐ Leaks

frame offset

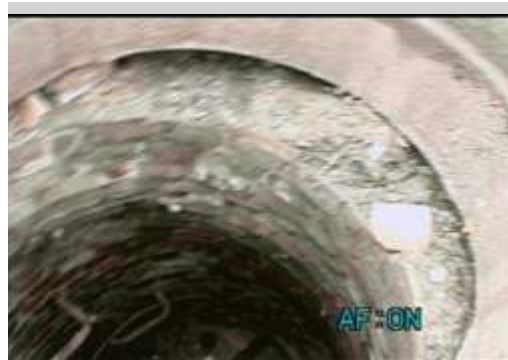
Defect 1

Condition: ☐ Sound ☐ Cracked ☐ Root Intrusion ☒ **Loose Brick** ☐ Deteriorated

chimney loose bricks

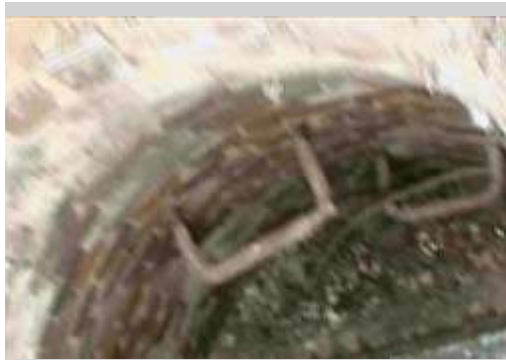
Defect 3

**Steps** Count: **3** Missing: **1** ☒ **Corroded**

corroded steps

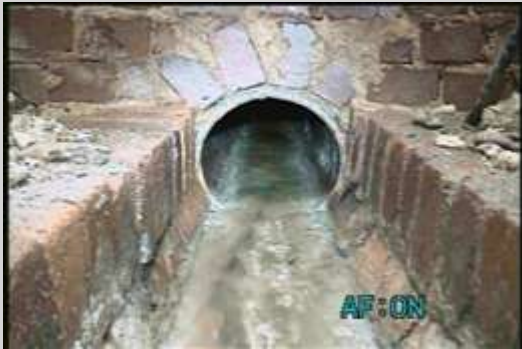
12 O'Clock Outflow

8 in. Circular Gravity Sewer  
Pipe Out @ 12 O'Clock

Invert Depth: 7.95 (ft.) Flow Characteristics: **Fast**

Infiltration: **None** Pipe Seal Cond: **Unknown**

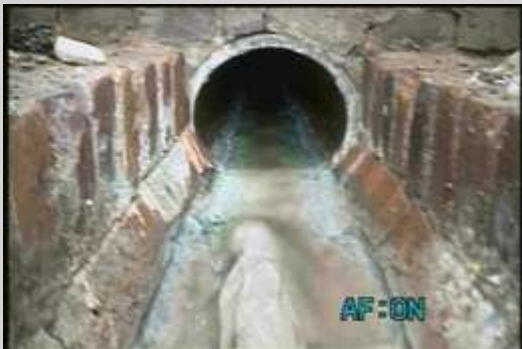
6 O'Clock Inflow

8 in. Circular Gravity Sewer  
Pipe In @ 6 O'Clock

Invert Depth: 7.80 (ft.) Flow Characteristics: **Fast**

Infiltration: **None** Pipe Seal Cond: **Unknown**
